EAST ELEVATION

CHISANA

HISTORIC STRUCTURE REPORT

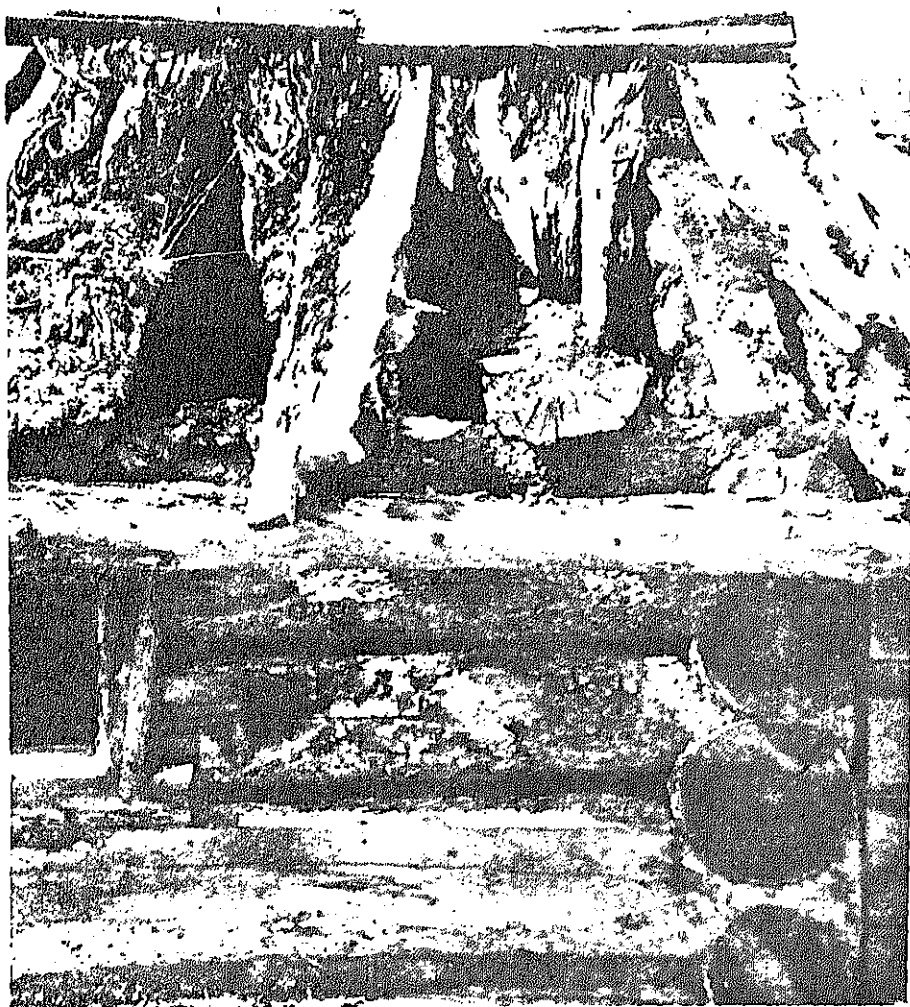
Photograph 6
Women's Jail, Chisana
"Hole-in-Roof" Detail, South Side.

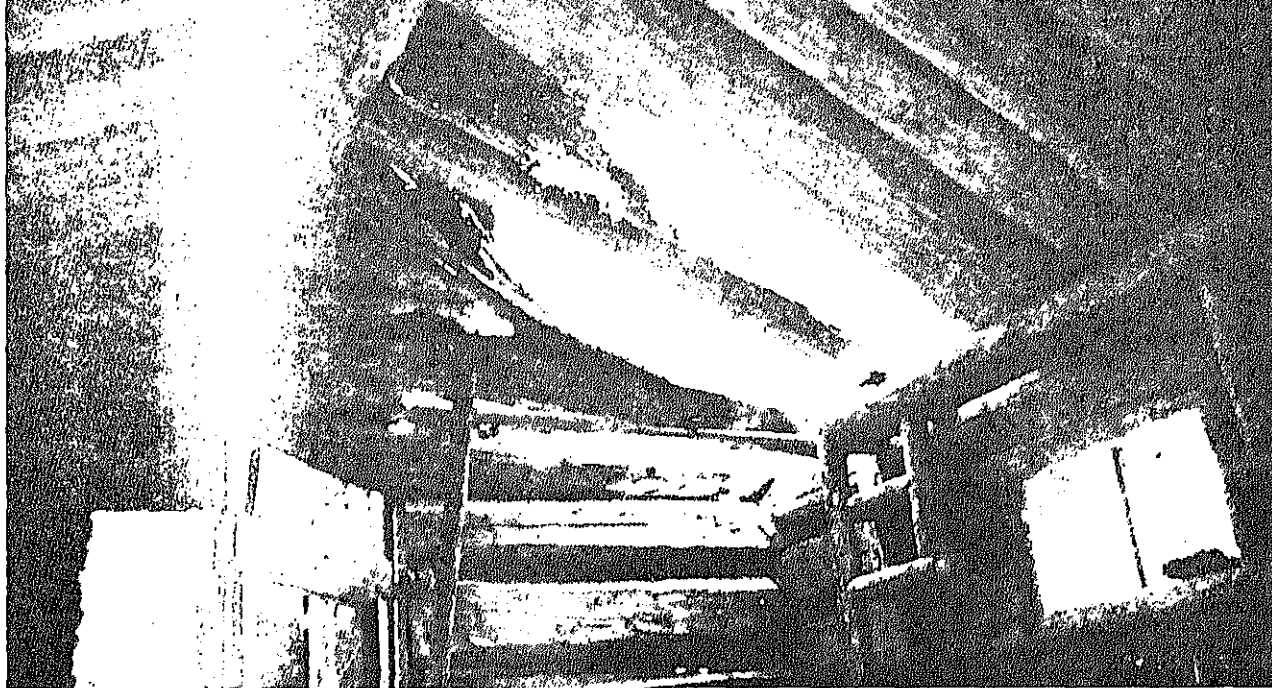
Photograph 7
Women's Jail, Chisana
Collapsed Ceiling, South Side.

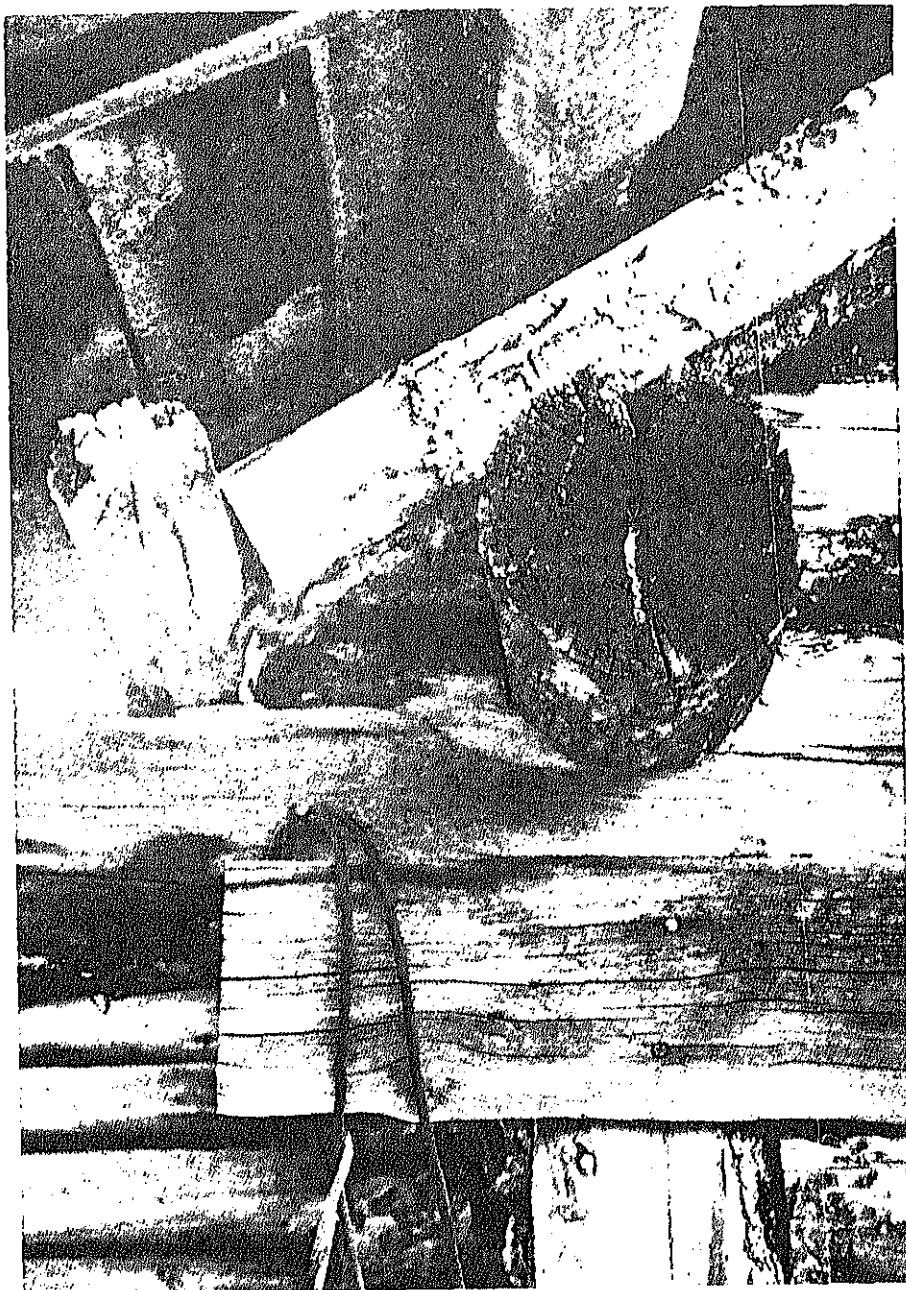
Photograph 19
U.S. Commissioner's Court, Chisana
Junction of the ceiling timbers,
butting pole, eave log and
plate log w/newer roof above
ceiling members

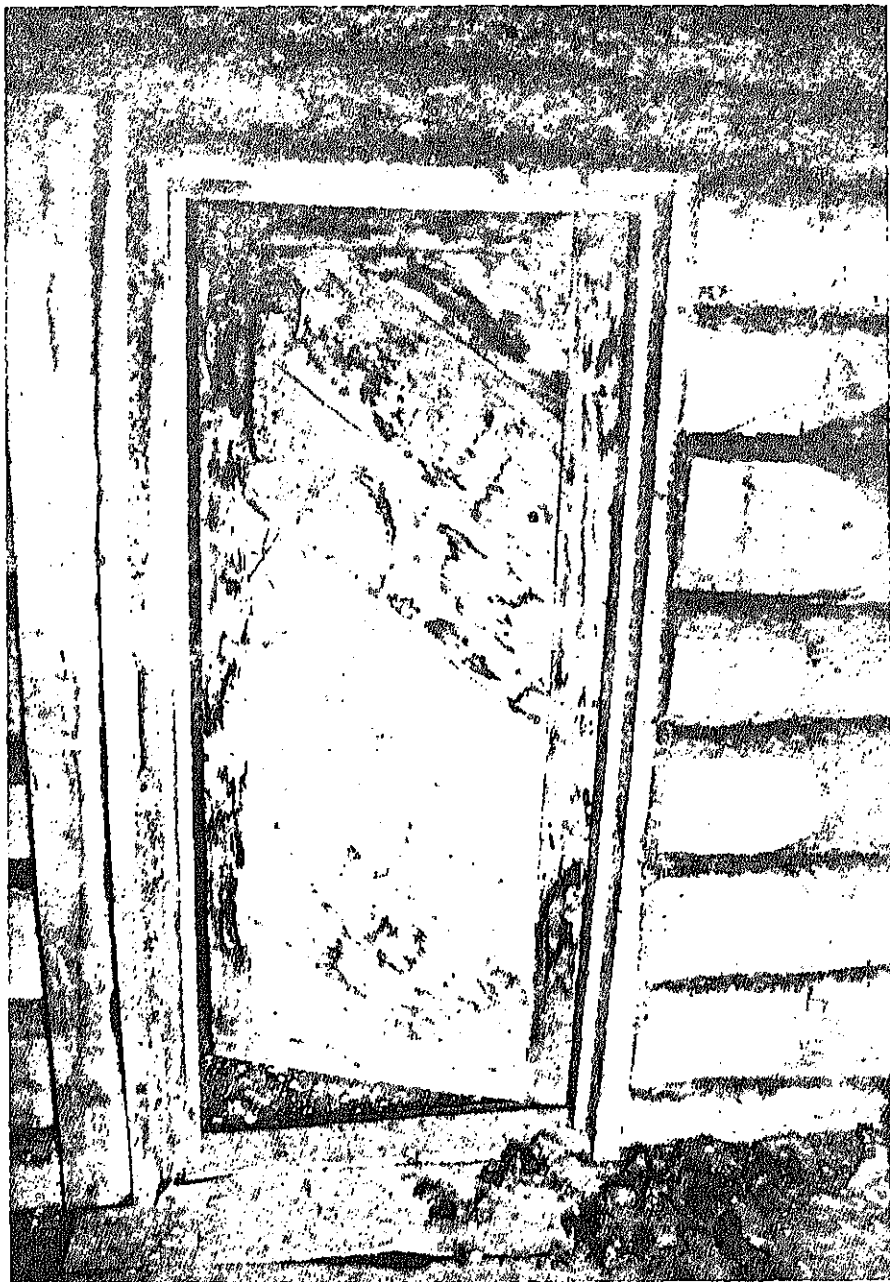
Photograph 23

U.S. Commissioner's Court, Chisana
Front entry to main cabin with hewn
logs at trim; trim missing on
right side.

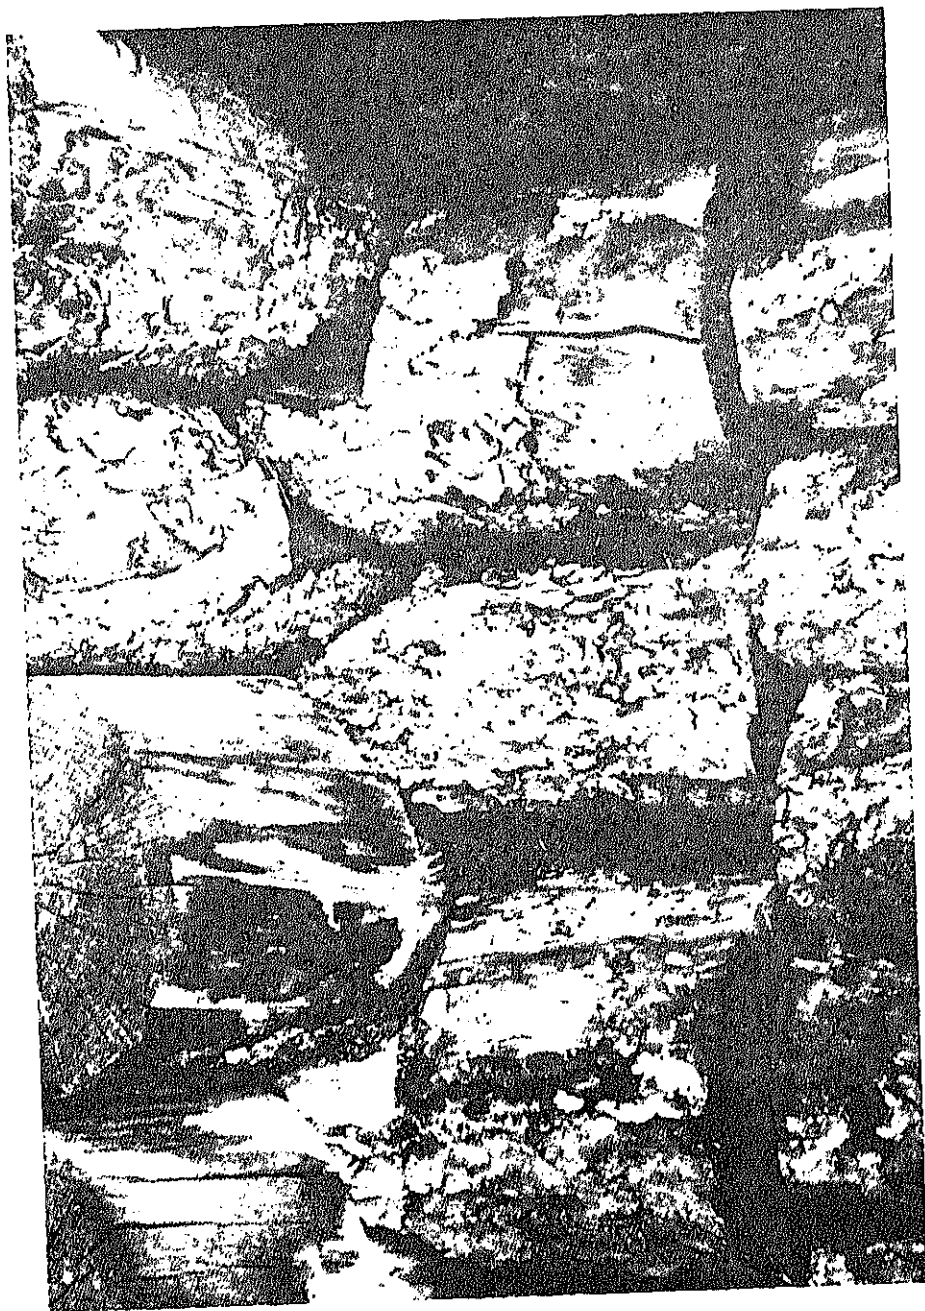
Photograph 24

Junction of main cabin logs and
porch logs (spline just visible
between second and third porch logs
on right)

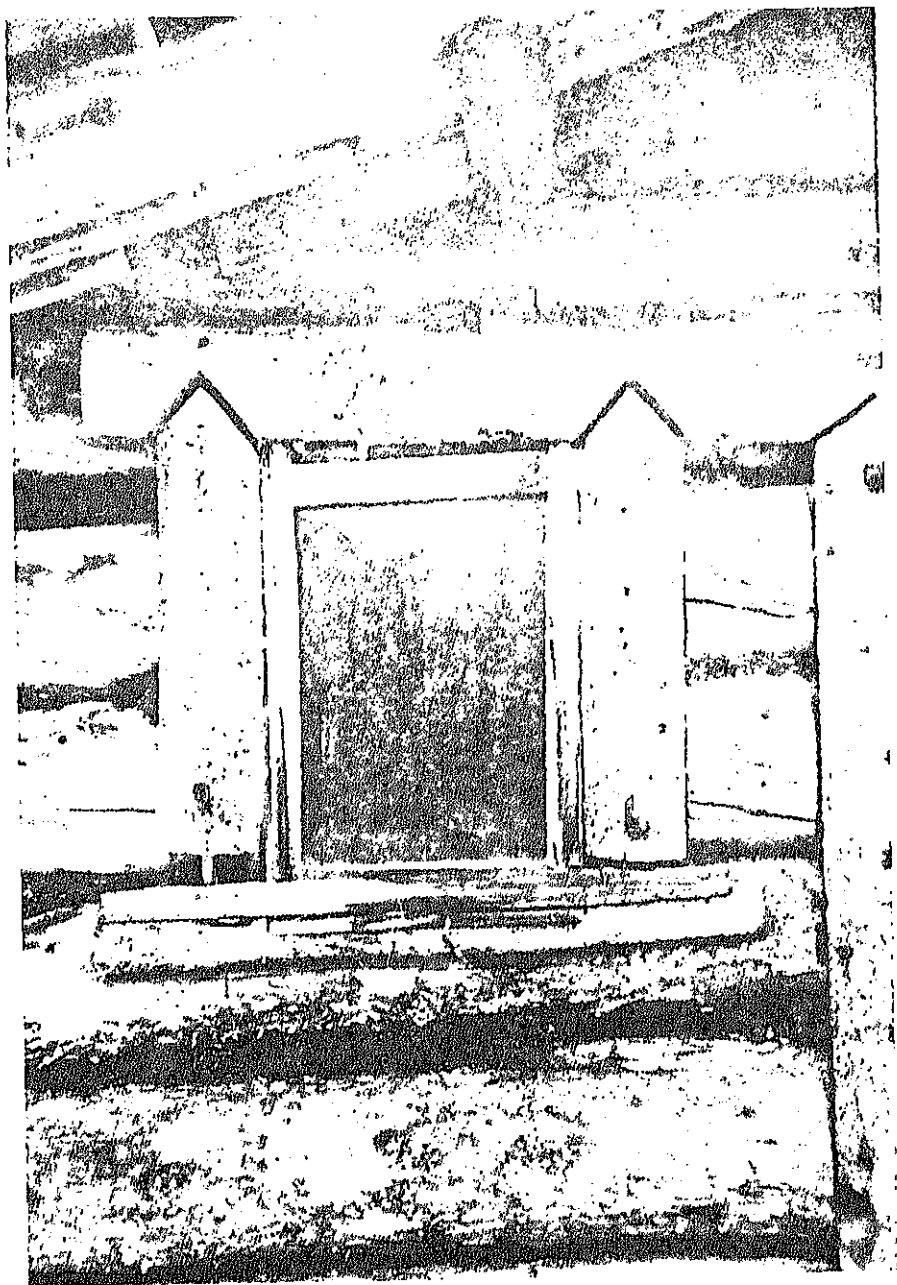
Photograph 42

Front window with racked frame and
seperating trim (note pegs nolding trim
in place).
